Combined Surgical Therapy and Orthotic Management of Stress and Tuberosity Avulsion Fracture of the Fifth Metatarsal Bone

A Case Report

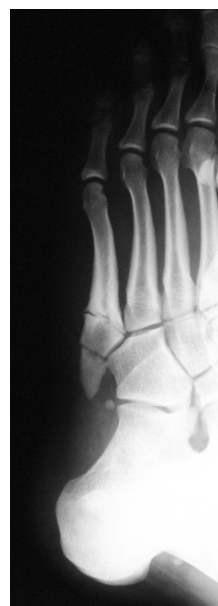
Figure 1. Preoperative radiograph of the injured foot.

An 18-year-old basketball player (weight, 75 kg; height, 187 cm) presented to the Department of Traumatology, General Hospital Varazdin, Croatia, with persistent, sharp pain in his left foot. In the previous 6 months during his training and matches, he repeatedly had pain in his left foot localized around the base of the fifth metatarsal. After a jump, he felt sudden, sharp pain and was taken to our hospital. He was clinically and radiologically examined. Clinically, he was found to have a bow-leg deformity with over-supination of both feet. A series of standard radiographs of the left foot showed a stress fracture of the proximal third of the fifth metatarsal and an acute tuberosity avulsion fracture (Fig. 1). After meeting the criteria for surgical intervention, the operative treatment of percutaneous intramedullary screw fixation with a 4.5-mm malleolar screw was undertaken (Fig. 2). The physical therapy started at the first postopera-

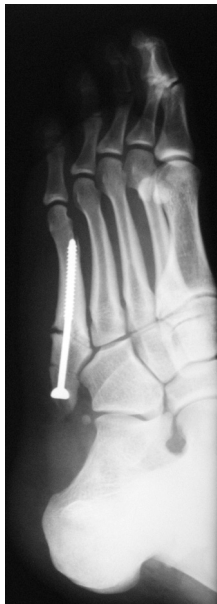
Figure 2. Postoperative radiograph on day 1.

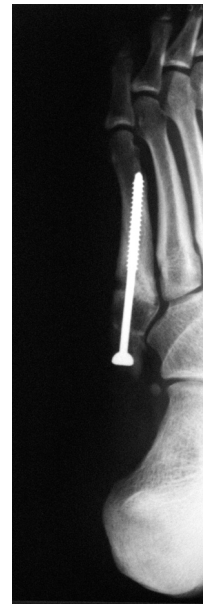
Figure 3. Radiograph 8 weeks postoperatively.

tive day in the ward and continued in the infirmary for the next 10 weeks. During the first 2 weeks following the operation, the patient was advised to avoid weightbearing on the injured leg and to use crutches. The patient followed-up 10 weeks after the surgery. Radiography showed good healing (Fig. 3), and the patient was allowed to start with low-intensity training. Training intensity was gradually increased

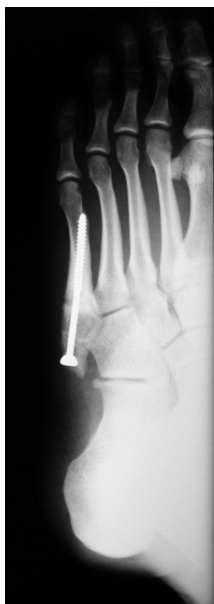
Figure 4. Radiograph 12 weeks postoperatively.

during the following 3 weeks, until full sports activity was approved. After 13 weeks, radiographs showed that both fractures healed completely (Fig. 4). The final evaluation took place 1 year postoperatively, and there was no clinical or radiologic sign of nonunion or refracture (Fig. 5).

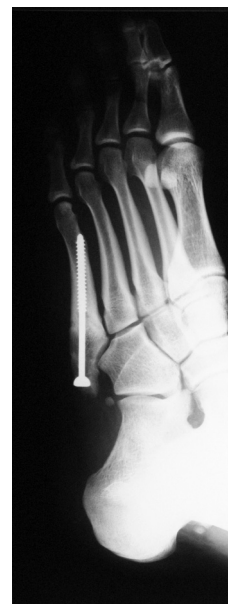
Figure 5. Radiograph 1 year postoperatively.

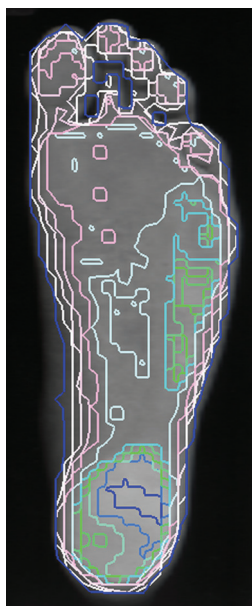
Figure 6. Static foot pressure measurement showing connected isobars view of the right foot.

(Corkitdoo, Zagreb, Croatia) where additional tests were conducted. Custom-made functional foot orthotic devices were recommended. The static foot pressure measurement was made with the optical pedobarograph and Insole Modeller CAD/CAM system (Next Step Footcare, Houston, Texas). This system generates a relative semi-quantitative pressure map from the feet images and scan. The pressure pattern on the right foot clearly shows an increased load beneath the head of the fifth metatarsal bone, and overall increased pressures along the plantar aspect of the fifth ray. There is also a prominent pressure spot under the base of the fifth metatarsal bone (Figs. 6 and 7). Since the patient has bow-leg deformity, the oversupinated foot condition was actually expected to be an adjacent condition.¹³ On the contrary, the pressure pattern of the surgically treated left foot showed slightly increased pressures beneath the heads of the third and the fourth metatarsal bone. Although the patient still favors the lateral side of the foot from being overloaded (from surgery), there is significant pressure relief under the fifth ray plantar projection, when compared to the right side. High pressure spots under the base and the head of the fifth metatarsal bone were absent on the left but visible on the right side (Figs. 8 and 9). Natural range of movements in the subtalar joints are preserved bilaterally. The contours of the feet were symmetric, with no other major aberrations. Mobility of the small joints are maintained to

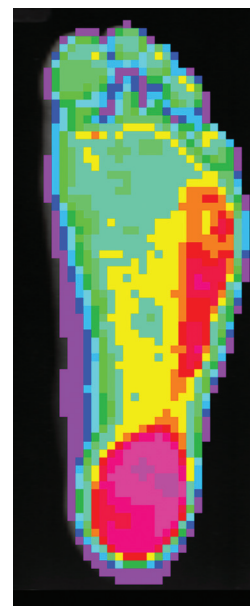
Figure 7. Static foot pressure measurement showing map of pressure values of the right foot.

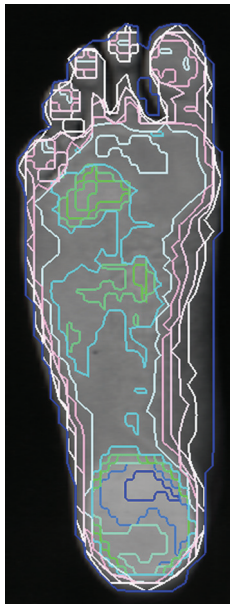
Figure 8. Static foot pressure measurement showing connected isobars view of the surgically treated left foot.

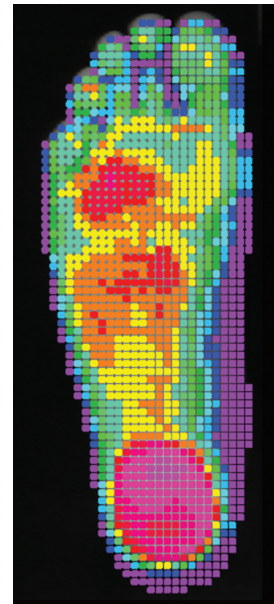
Figure 9. Static foot pressure measurement showing map of pressure values of the surgically treated left foot.

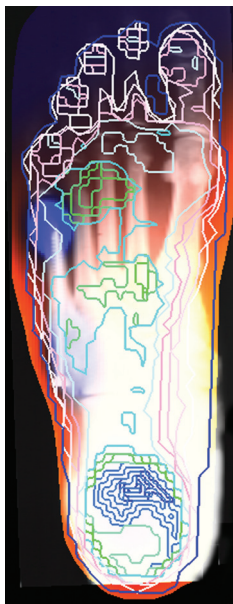
Figure 10. Computer aided design showing reliefs on insole surface, navigated by radiograph and pressure image in background, with surface transparency turned on.

Special attention was given to the fracture location. The proprietary software allows the designer to import the digitized radiographic actual-size foot image (dorsoplantar and laterolateral aspect) into the design module. The image was superimposed over the surface acquired by the 3-D digitizer with transparency set to 50%. In this way, the alignment of the image over the surface was simplified, while all of the features on the surface and radiographic image were maintained and visible. This procedure dramatically increased accuracy of the pressure relief placement (Fig. 10). This method also allowed an overview for positioning the intramedullary screw in regard to foot orthosis, so design could be adjusted in order to reduce its stress (Fig. 11).

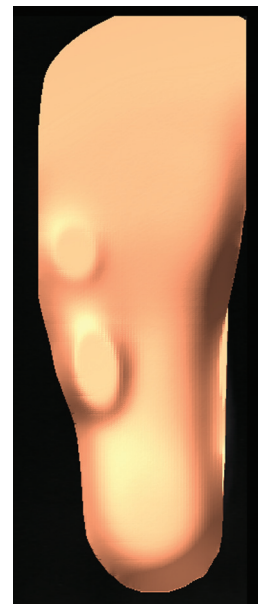
Figure 11. Computer aided design showing adjusted insole surface with accommodations.

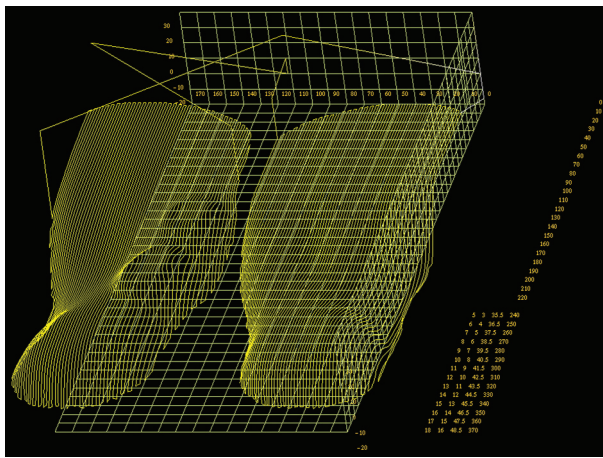
Figure 12. Computer aided design showing generated computer numerical controlled milling machine tool path for a pair of the foot orthotic devices.

The orthotic base material was homopolymer-polypropylene (Otto-Bock Healthcare GmbH, Duderstadt, Germany) with trilaminar top cover. With the design complete, the tool path for the numerical controlled milling machine was generated (Fig. 12). We used a boiled beech wood as a base mold material. The molding process was interrupted when the plastic was cooled down to room temperature. The plastic shell was posted with 65° ShA neoprene rubber

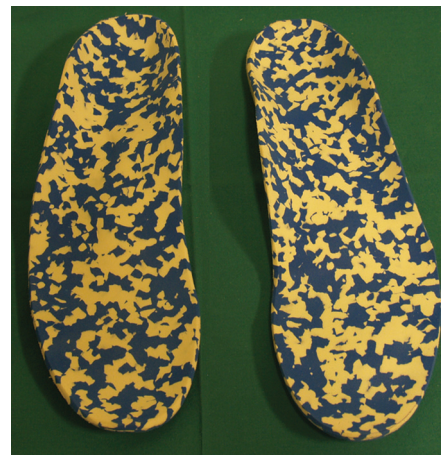
Figure 13. Photograph showing the manufactured orthoses.

neutral post (Fig. 13). The patient acclimated very quickly to the orthotic device and noticed a decrease in pain and an increase in activity compared to a no-orthotic condition (Fig. 14). Two years postoperatively, he is an active basketball player and has no symptoms.

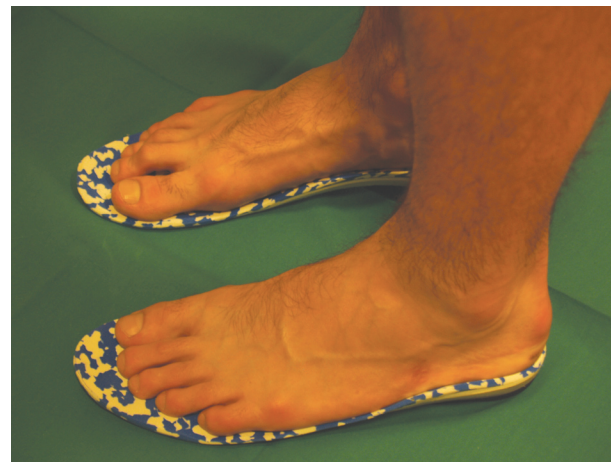
Figure 14. Photograph showing the patient standing on the orthoses.

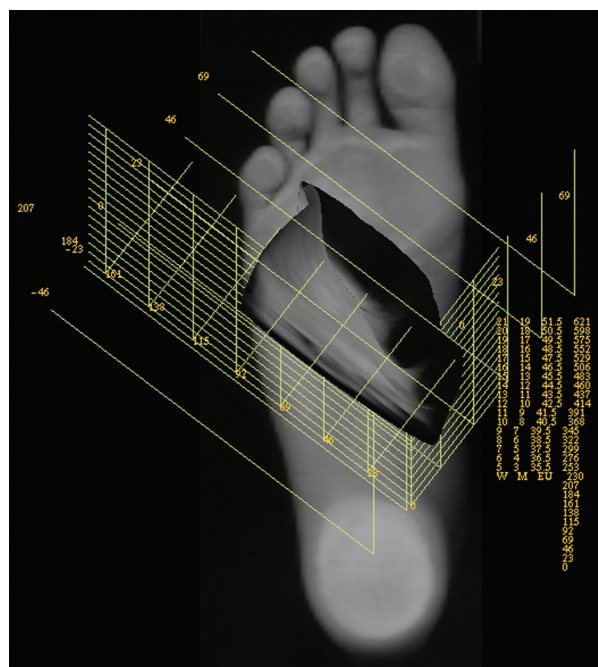
Figure 15. Computer aided design showing textured view of the insole surface. Note an adjustment on the base of the fifth metatarsal bone.
